Heat Exchanger – Inspection Cover Torque Requirements

Models: All Bosch Greenstar Boiler Products

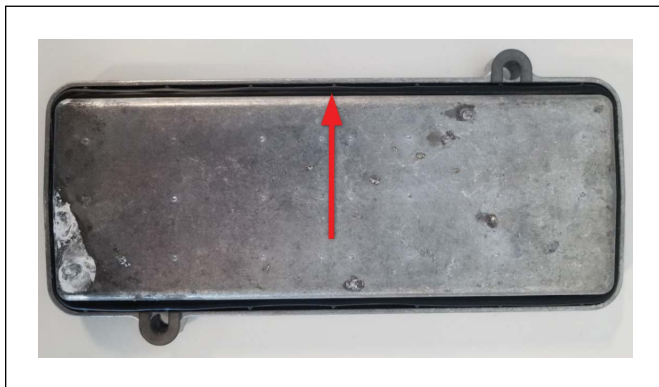
Figure 1

1. Inside the rear edge of the inspection cover is a black sealing gasket (part# 87101031530). We recommend replacing the existing gasket with a new one whenever the inspection cover is removed (see fig. 1):

To ensure that no by-products of combustion (flue gases or condensate) leak from the heat exchanger inspection cover after it has been removed and replaced, and to prevent E9 error codes that are caused by such leaks, we recommend the following steps be taken:

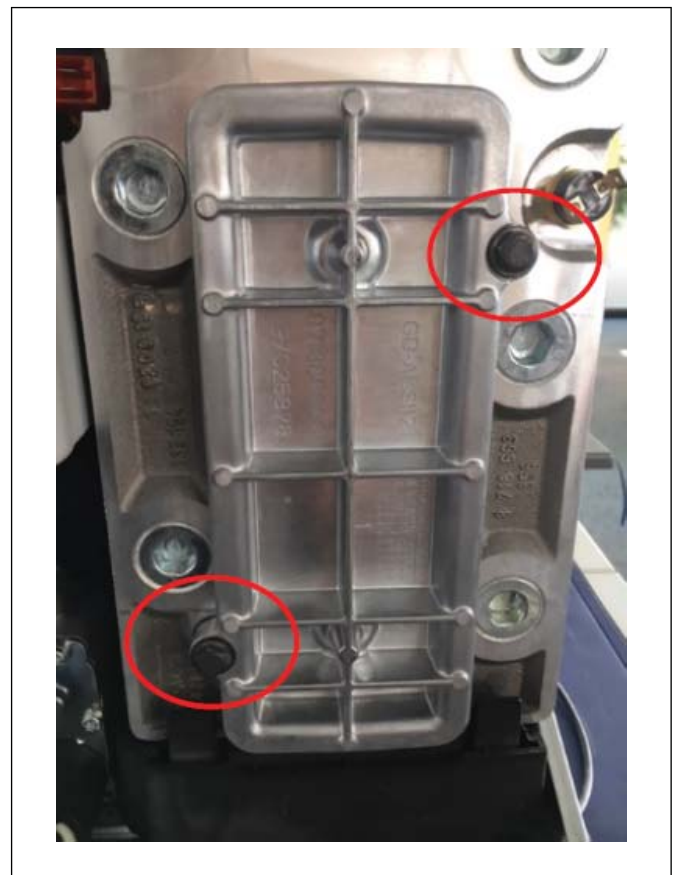
Figure 2

2. Once the inspection cover is back in place and the two bolts have been inserted (see fig. 2), ensure that the bolts are fastened down to a torque of between 4.1ft-lbs (5.5Nm) and 5.1ft-lbs (7.0Nm).

We also recommend checking that the torque requirements of these two bolts be checked as part of a startup best practice when installing Greenstar boiler products.
