Product Information Notice

Models: GB142-24,30,45,60

Brand: Buderus

Subject: GB142 Vent Adaptor Inspection

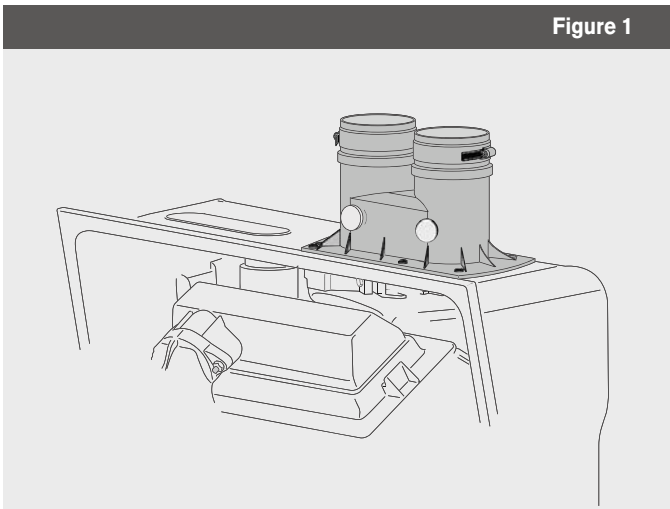
Figure 1

The aluminum vent adaptor has been modified and is now made of polypropylene to eliminate corrosion of the vent adaptor (see Fig. 1).

The polypropylene adaptor (p/n 8718600686) has an internal condensate drain which eliminates the need for an external condensate tee previously required with the aluminum vent adaptor.

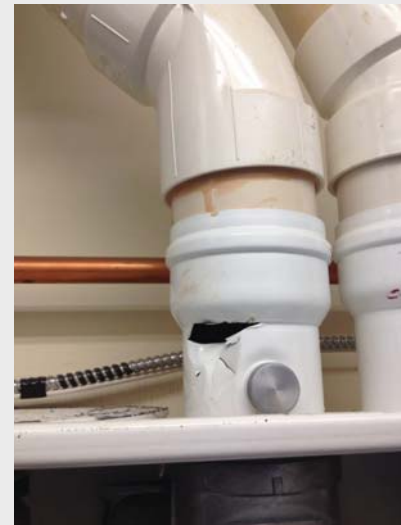
Figure 2

GB142 boilers produced prior to March 2012 were manufactured with an aluminum vent adaptor (p/n 28268). It has come to our attention that if an external condensate drain has not been installed or has been installed too far away from the GB142, accumulation of acidic condensate may cause corrosion of the aluminum vent adaptor (see Fig 2).

If there is any evidence of damage to the vent adaptor the vent adaptor should be replaced.

While there is nothing wrong with the quality of the original aluminum vent adaptor, if there is damage or a question of damage to the vent adaptor a replacement vent adaptor shall be provided by Bosch Thermotechnology at no charge.
