# Product Information Notice

**Models:** Greenstar Combi 151p (7738100611)

**Subject:** Incorrect Hydraulic Connection Plate

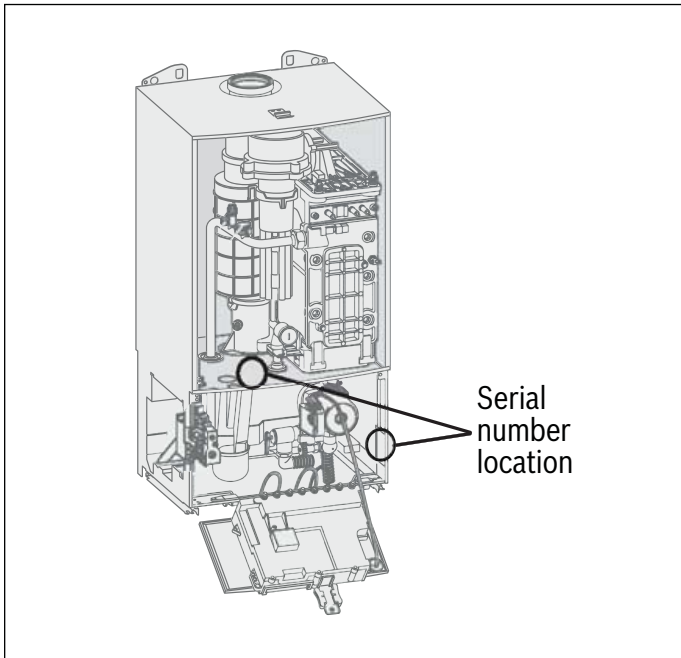
Figure 1

The boiler serial number is located on top of the packaging box or on the inside of the boiler (see fig1.)

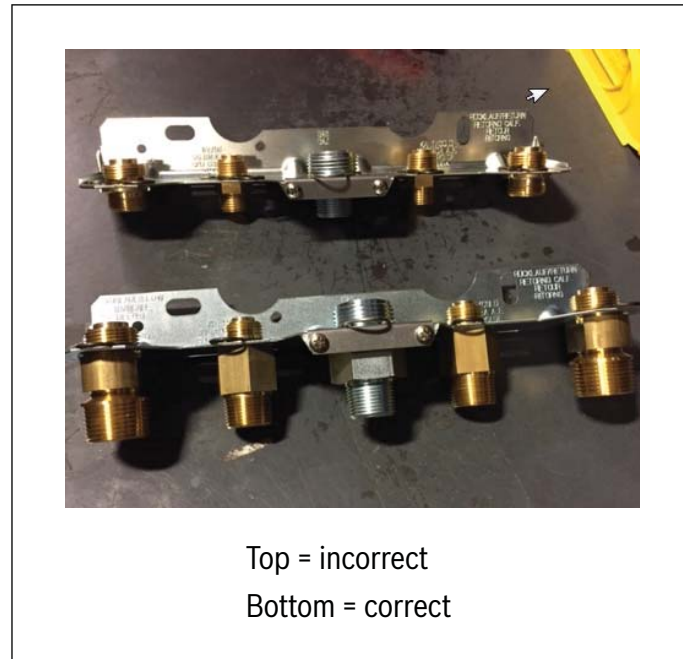
Figure 2

A limited amount of Greenstar Combi 151p boilers were packaged with a hydraulic connection plate (p/n: 87186616160) containing incorrect connection fittings. These connections are not NPT and will not properly connect to the boiler (see fig2.)

Affected units were produced between April 2017 and May 2017 and contain a serial number with the date code "720" and "753".

The issue has been corrected at the factory and all subsequent shipments contain the correct hydraulic connection plate.

If a customer has an affected unit, please contact Bosch customer support for a replacement hydraulic connection plate or to return uninstalled product in inventory for rework.

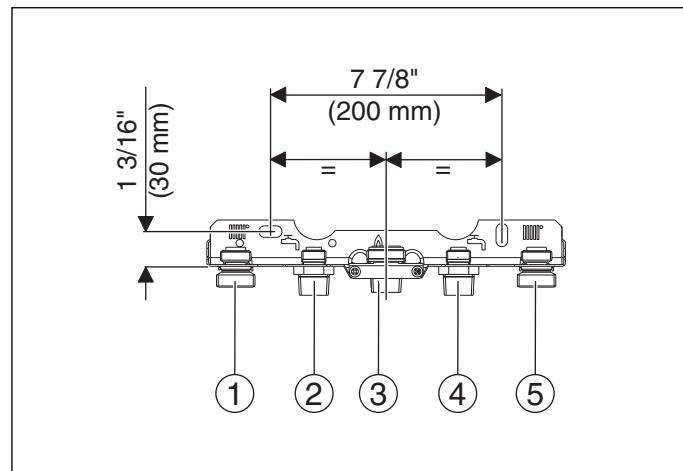
Figure 3 Correct hydraulic connection plate dimensions

- [1] Heating supply, R 1" NPT
- [2] DHW, R 3/4" NPT
- [3] Gas, R 3/4" NPT
- [4] Cold water, R 3/4" NPT
- [5] Heating return, R 1" NPT
